Stainless steel corrosion in instrumentation pipe

Corrosão do aço inoxidável em tubing de instrumentação

- ¹ Jean Victal do Nascimento
¹ Rafael Adão de Carvalho
¹ Davi Pereira Garcia davi.garcia@ifes.edu.br
² Rômulo Maziero
² Edelize Angelica Gomes
² Juan Carlos Campos Rubio

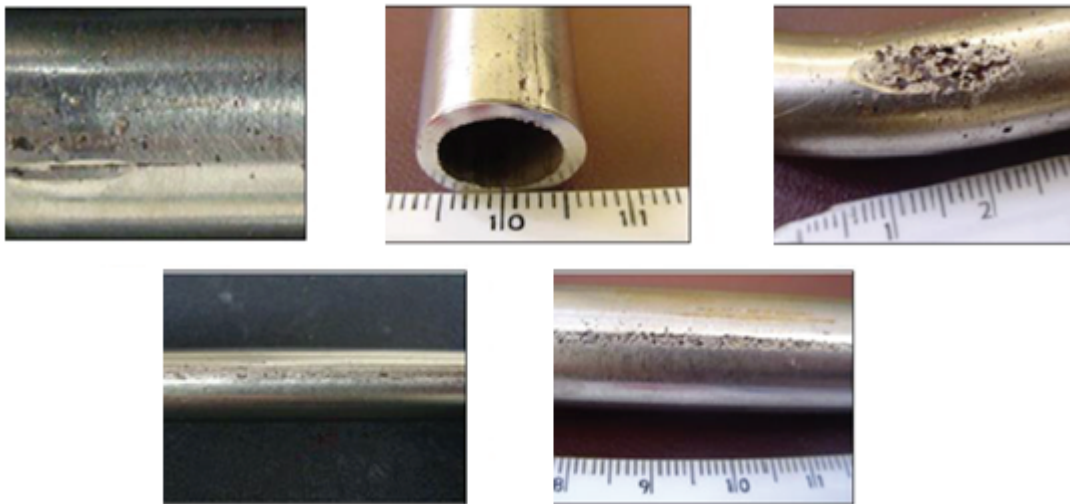
The visual evaluation of the TF samples allowed to identify the presence of localized pitting corrosion associated to loss of significant material, according to Figure 1.

Figure 1 - Predominance Pitting Corrosion in the Tubings.

Figure 1 shows the most critical points in which the material has suffered corrosion and is important for identifying the type of corrosion presented, in this case pitting. According to Telles (2003) and LI et al. (2018), this type of corrosion occurs due to rupture of the passive film and propagation of pitting when in the presence of halogen ions.

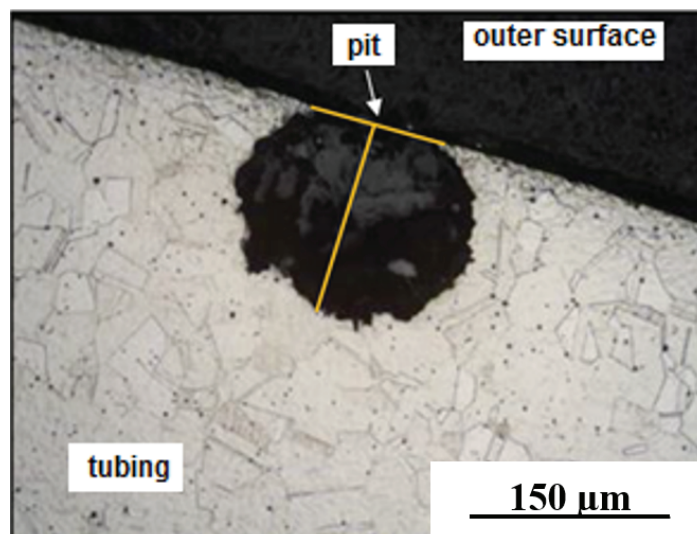
Figure 2 - Microscopic appearance evidencing pitting on the external surface.

Figure 2 shows the identification of the pitting according to ASTM G46 (2013), which shows a greater depth of penetration in the metal in relation to the penetration surface. The morphological

analysis allows inferring that it is a pitting of the subsurface type since it did not reach the internal region of the tubing.

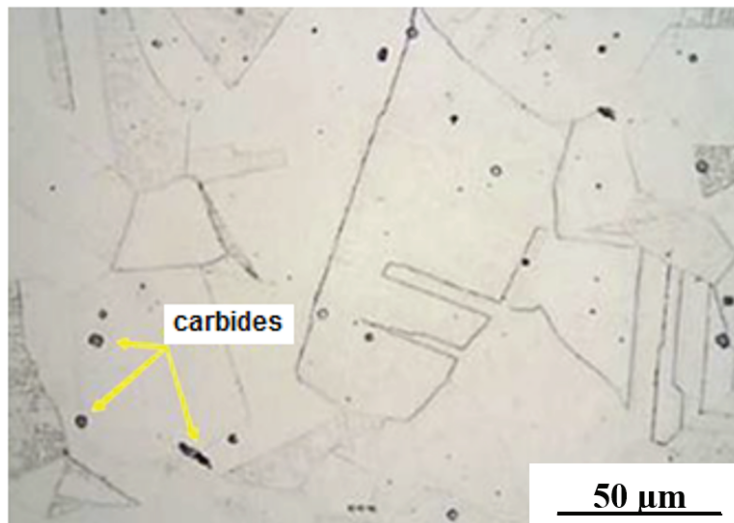
Figure 3 shows the microstructural aspect of the TF sample after conventional metallographic preparation and electrolytic attack based on oxalic acid in cross section.

Figure 3 - Metallography of samples. .

The results show that there is no change in the longitudinal and transverse structure for all analyzed tubes, showing a homogeneous austenitic structure, free of intergranular precipitations. Thus, the preferential sense of pitting occurrence was not motivated by any microstructural changes. It is possible to observe the formation of carbides of bulky and dark bodies dispersed in the austenitic matrix (arrows in yellow). These carbides are likely to result from the cooling process slowly.

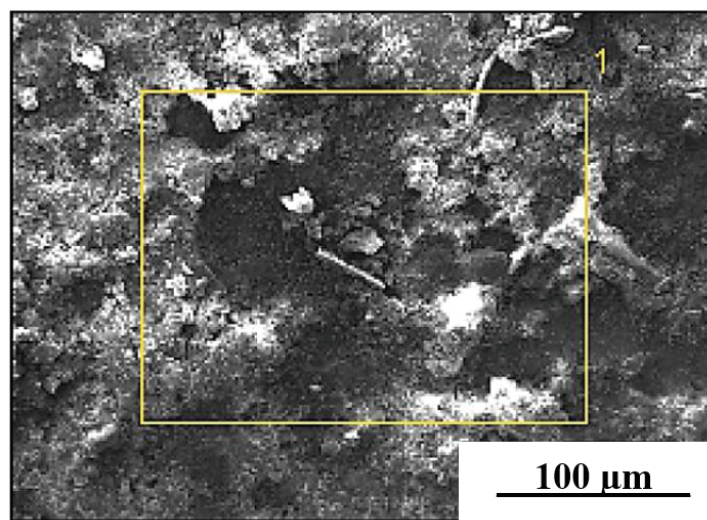
Figure 4 represents the sample collected in the corrosion products of the external surface analyzed by MEV, with subsequent microanalysis by EDS.

Figure 4 - The sample for EDS analysis.

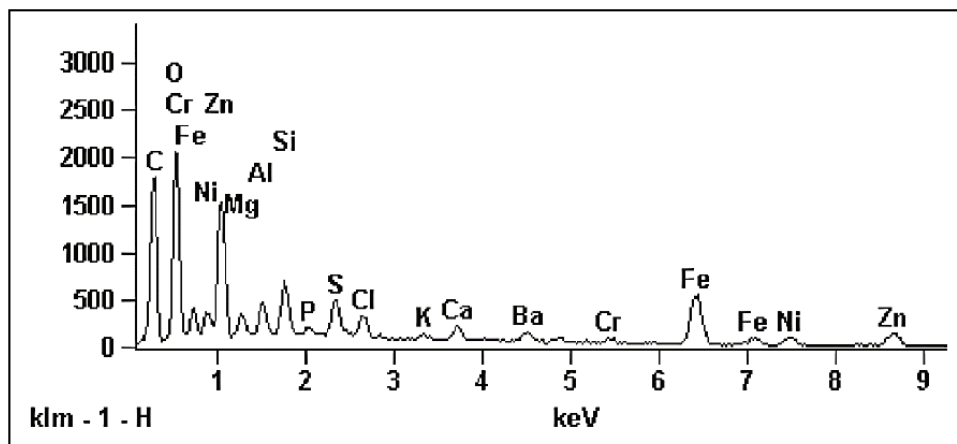
Figure 5 shows the presence of elements typically found in the marine atmosphere (Cl, Na, K, Ca and Mg), as well as Si, S, Fe, Al, Zn, Ba, Cr and Ni as peaks of the chlorine element, main responsible for the rupture of the passive protective film.

Figure 5 - EDS analysis of the products collected on the surface of the tubing. .
